Waste Disposal

Waste Burial and Repository

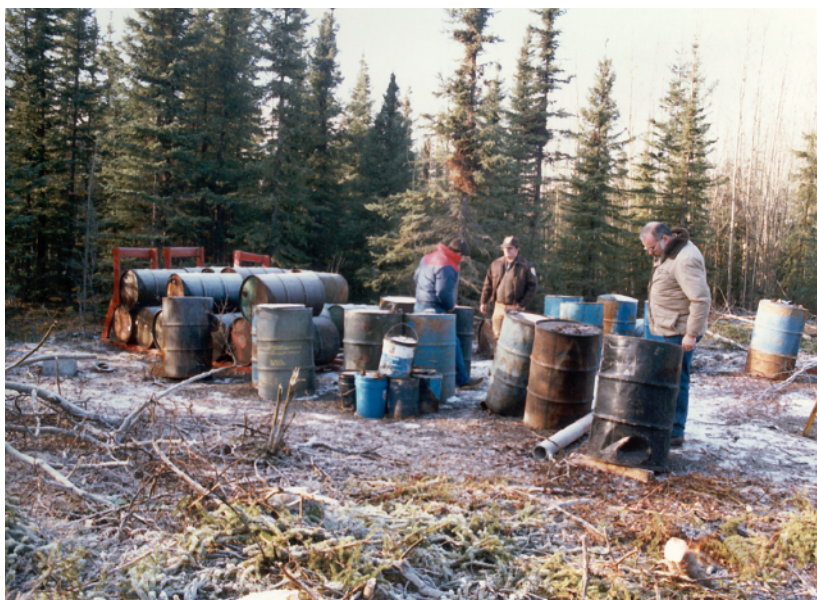
Liquid-filled 55-gallon drums at the Skilak Boneyard prior to proper removal and disposal. USFWS Photo by Robert A Richey.

In 1988, refuge personnel initiated a large-scale cleanup at the boneyard. During cleanup efforts, 47 drums with various contents were discovered; 31 drums were full or partially full. Two of the drums contained pentachlorophenol (PCP). In 1992, 300 cubic yards of soil were excavated and then remediated by land spreading. All drums were disposed of in accordance with State and Federal regulations. On December 30, 1993, ADEC determined no further action was needed at the site and approved site closure.

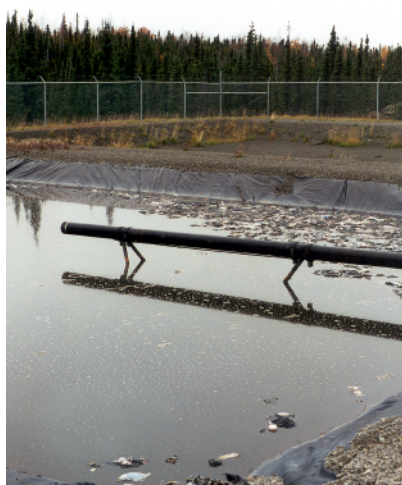
Recreational vehicle dump station and lagoon. USFWS Photo by Tiffany A. S. Parson.

Due to increasing recreational use on the refuge, an RV dump station and lagoon were constructed in 1993. The dump station and lagoon are located eight miles from the west entrance of Skilak Loop Road. The well is operated by a remote solar-powered generating system with liquid and solid wastes being gravity-fed into an open lagoon system. Although a fence surrounds the open lagoon, wildlife still could enter this area. The lagoon is lined, and there is no apparent evidence for leaching. Fecal coliform, total coliform, sewage, urea, other nitrogenous compounds and chemicals used to treat sewage can negatively impact water quality and human health, thus if the lagoon liner was ever breached, groundwater in the area could be negatively impacted.

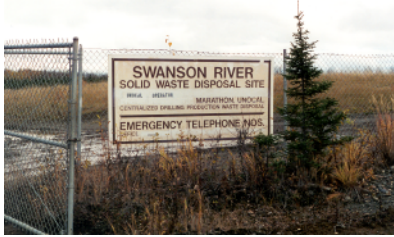
Solid waste facility at Swanson River Field. USFWS Photo by Tiffany A. S. Parson.

It was not until 1986 when a solid waste disposal facility was constructed at SRF. The 1-33 skim pit was used historically as a repository for SRF liquid wastes since the late 1950s, and it was not until 1990 when this facility was dismantled and replaced with an advanced separation facility. It should be noted that some concrete from the dismantled 1-33 skim pit was contaminated with PCBs; proper disposal occurred upon removal.

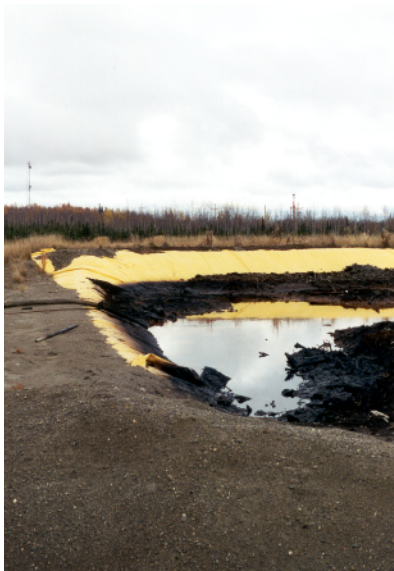
A closer look at one section of the Swanson River Field solid waste facility. USFWS Photo by Tiffany A. S. Parson.

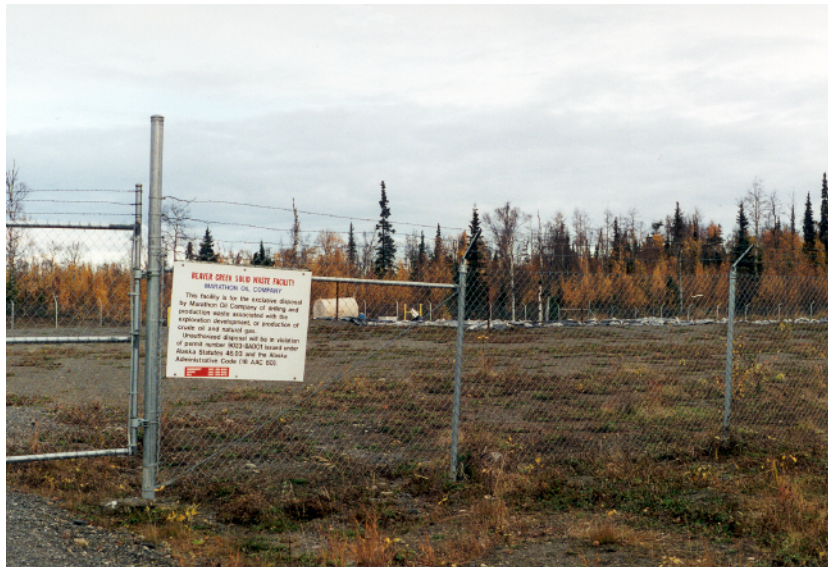
Solid waste facility at Beaver Creek Field. USFWS Photo by Tiffany A. S. Parson.

According to refuge personnel, prior to 1988 solid wastes were never permanently stored at BCF. Wastes were held in large plastic totes and when filled, they were taken off site for proper disposal. However, in 1988 waste disposal cells were constructed at BCF. SRF and BCF keep lists of the disposal contents.
